Increasing self-consumption of solar PV: Analysis of long-term performance of domestic solar PV installations

Paul Rogers and Michael Hamer

January 2023

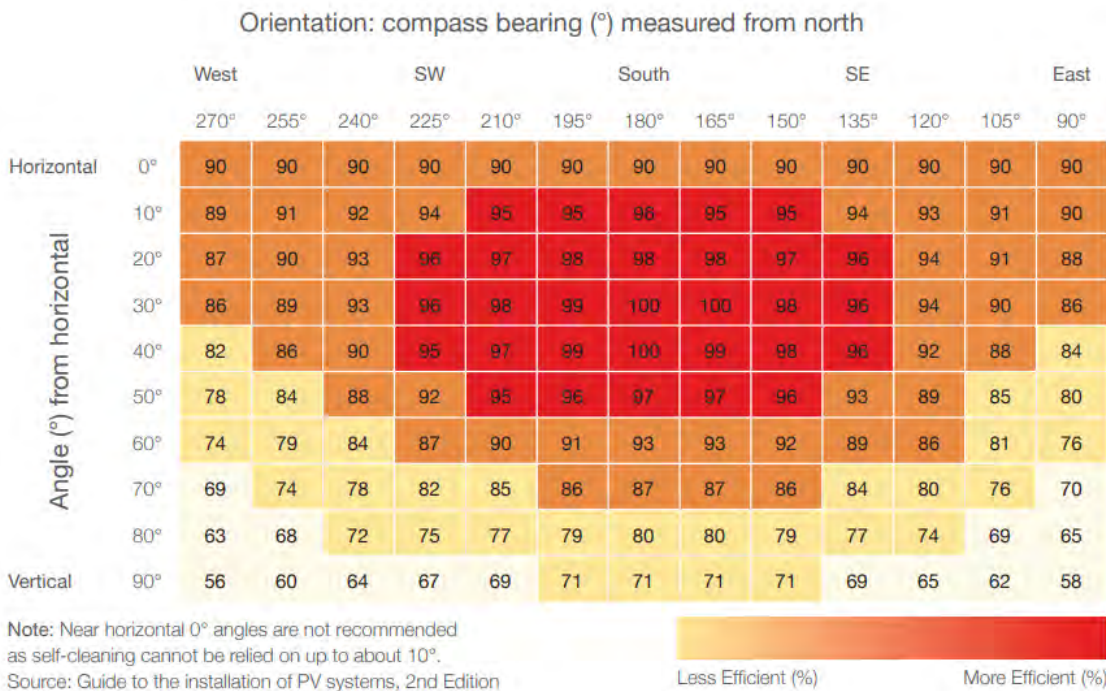
Figure 2.1 Percentage of the maximum possible yield from a solar PV system in the UK for different orientations and inclinations
(Graphic from Mitsubishi Electric Information Guide, Photovoltaic Systems, Issue 40)

The orientation and inclination of the solar panels affects the level of solar energy reaching the panels. In the UK, maximum annual generation will occur for a solar array that faces south on a roof inclined at about 35 degrees.

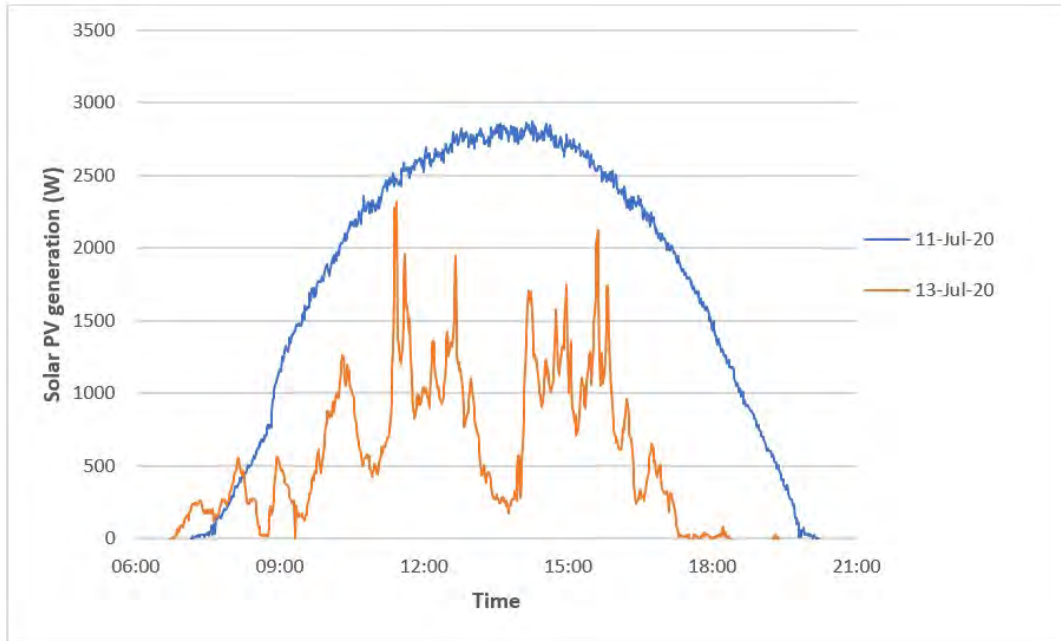
Figure 2.5 Graph showing PV generation on two days in July 2020, illustrating the impact of weather on electricity generated

Figure 2.5 shows that significantly more electricity is generated on a sunny day than on a cloudy day with less direct sunshine. Figure 2.6 shows there are high levels of solar PV generation between March and September. The monthly generation can however vary significantly between years. A sunny June can be followed by a damp and cloudy June the following year. There may be less variation in the annual generation than in the monthly generation as weather patterns can even out over a year.

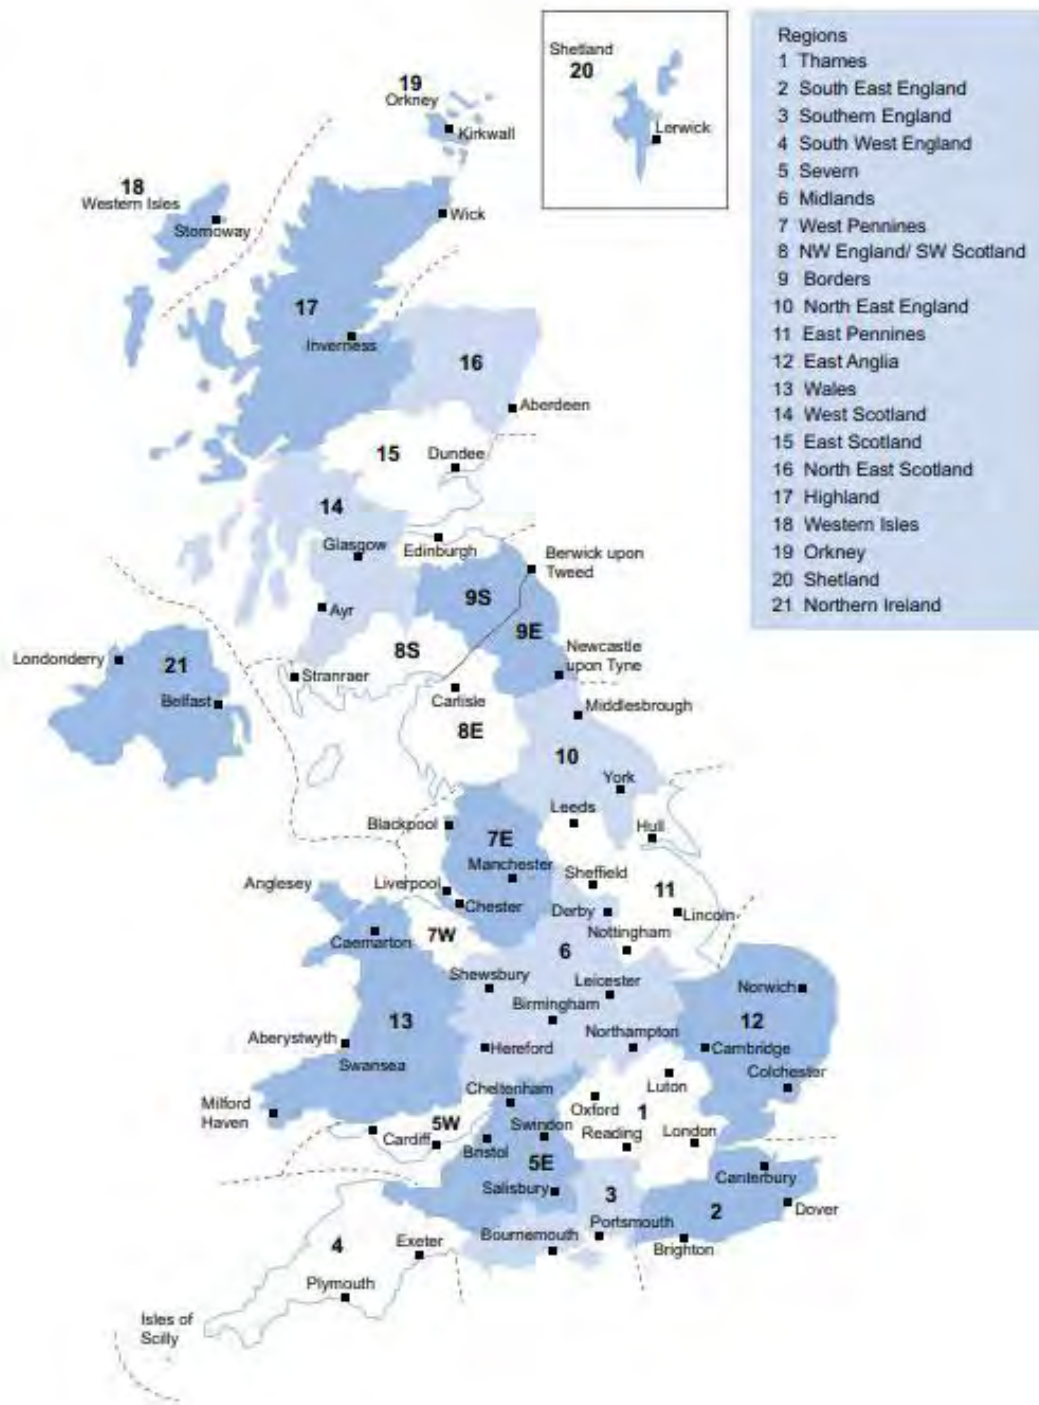
Figure 3.2 Map showing the 21 regions of the UK with tables for determining the value of Kk (From MCS MIS 3002 The Solar PV Standard)³

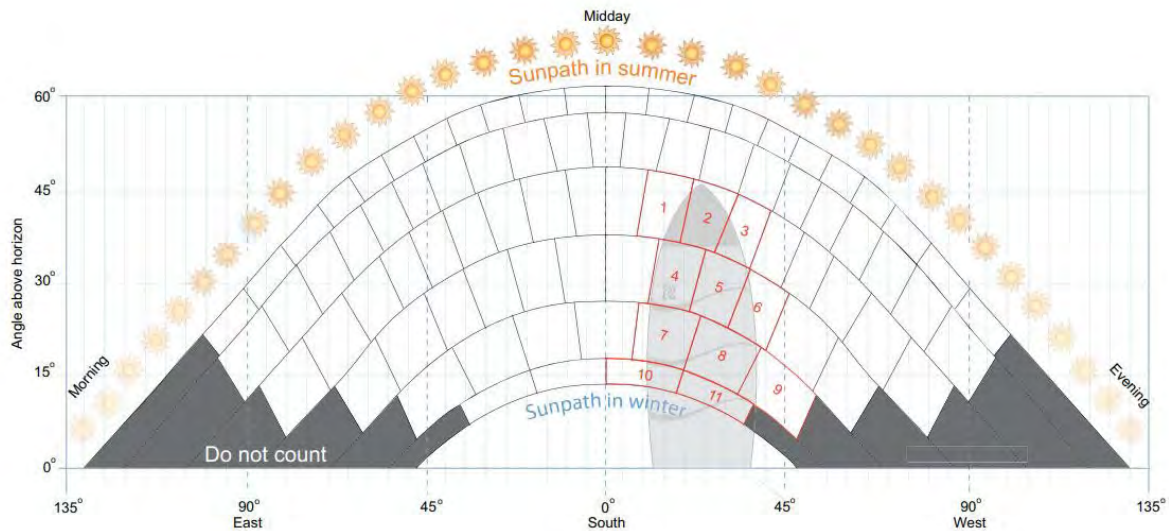
Figure 3.3 Sun path diagram showing an example shading assessment (From MCS Solar PV Shade Evaluation Procedure)⁴

Figure 3.3 shows an example sun path assessment. The diagram has 84 segments which each have a value of 0.01. In order to calculate SF, you first count the number of segments which are affected by the object. In the case of figure 3.3, this is 11 segments.

For figure 3.3,

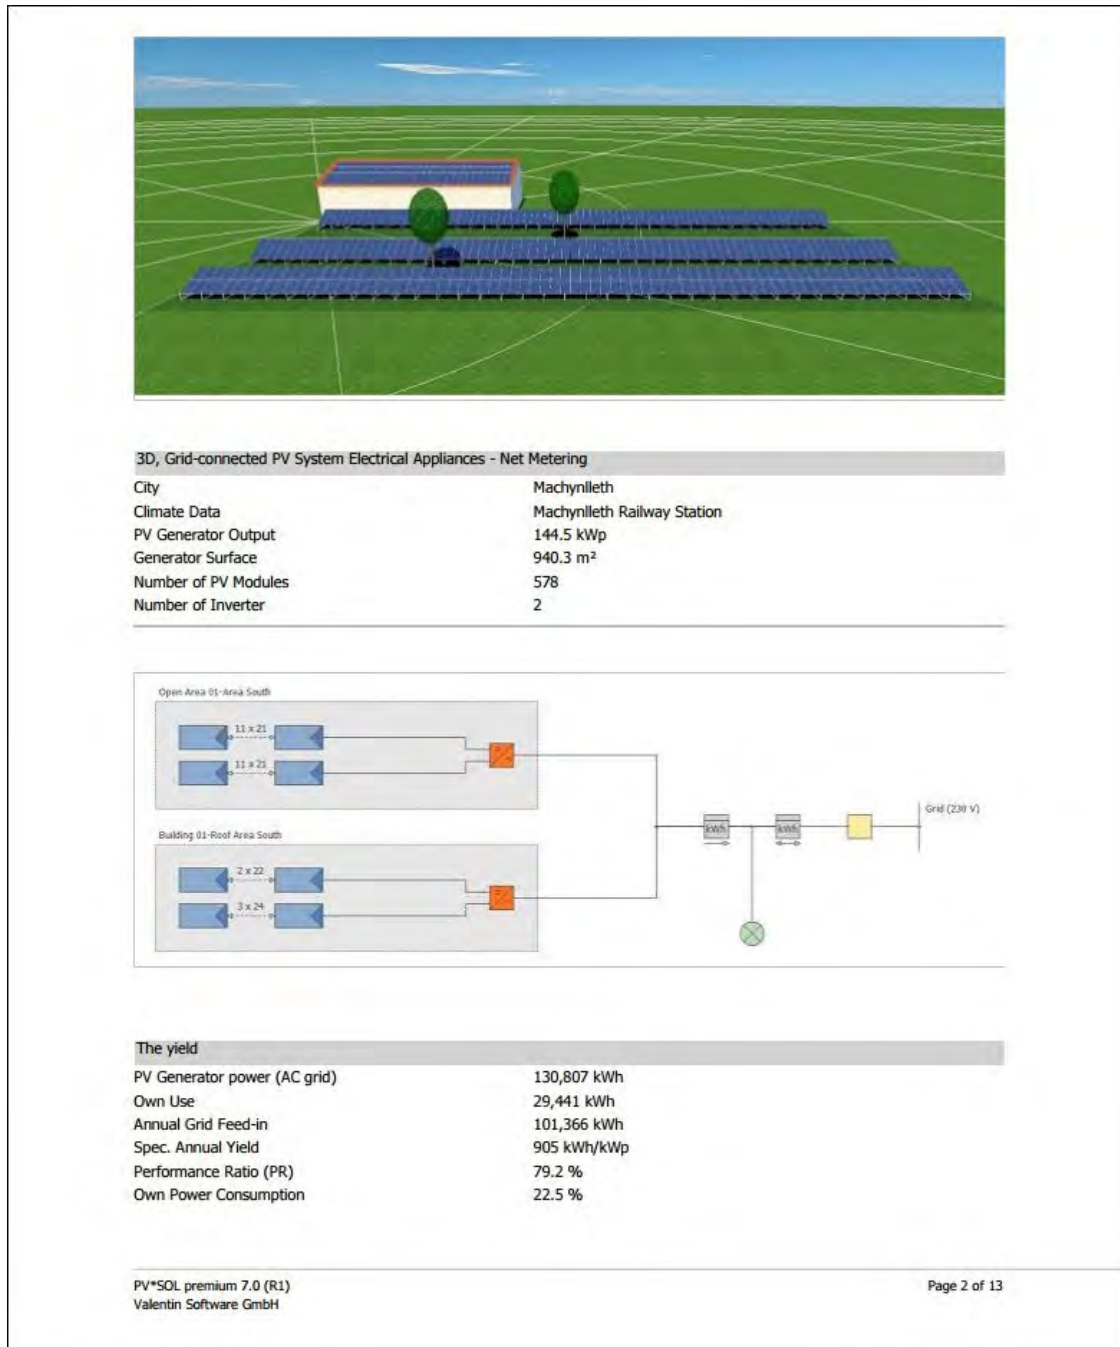
Figure 3.6 Image of a PV*SOL premium project report

PV*SOL is an advanced software package that is used by solar PV system designers. It will take into account the effect of location of the solar PV installation, its orientation and inclination on generation. It will also check the suitability of combinations of solar panels and inverters and show their impact on annual PV generation. There are advanced tools to assess the impact of shading. These include import of horizon profiles or modelling of buildings and objects in 3D. It can also import electricity consumption profiles and determine the likely level of self-consumption of the solar generated electricity.

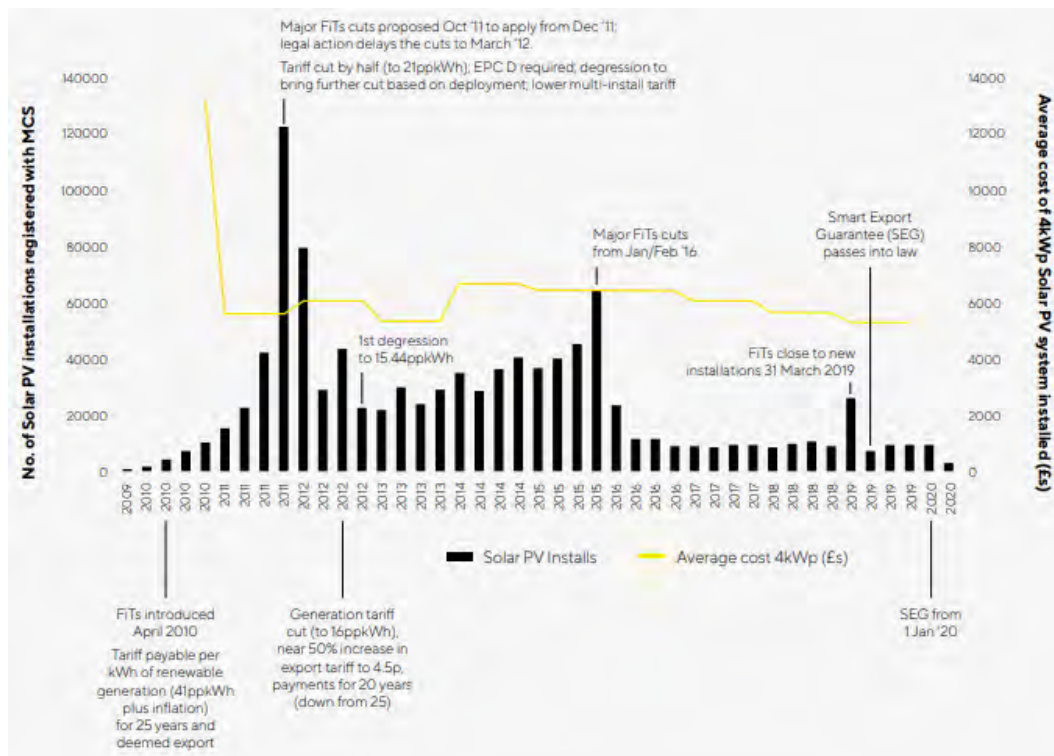
Figure 4.1 Variation in number of MCS registered solar PV installations during the Feed-in tariff⁶

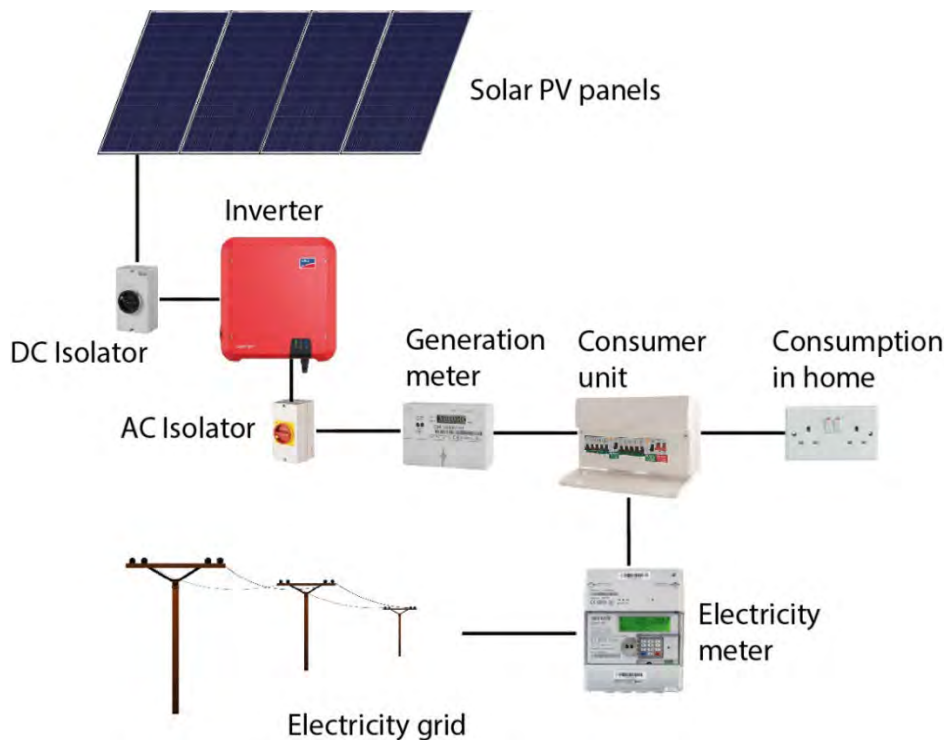
Figure 5.1 Schematic diagram of components in a solar PV system

Figure 5.1 is a schematic diagram of the components making up a solar PV system and shows how they connect into the home electrical system.

Solar panels generate direct current (DC) electricity. They are fitted on the roof with a mounting system that comprises of roof hooks, rails and clamps. There is a junction box on the back of the solar panel with wires coming out. The solar panels are wired together by plugging a male MC4 connector on one panel into the female MC4 connector on another panel.

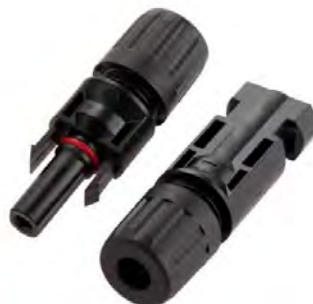
Figure 5.2 Male and female MC4 connectors which are used on solar panels

Damp getting into the MC4 connectors is a more likely cause of a fault than the failure of the panels themselves.

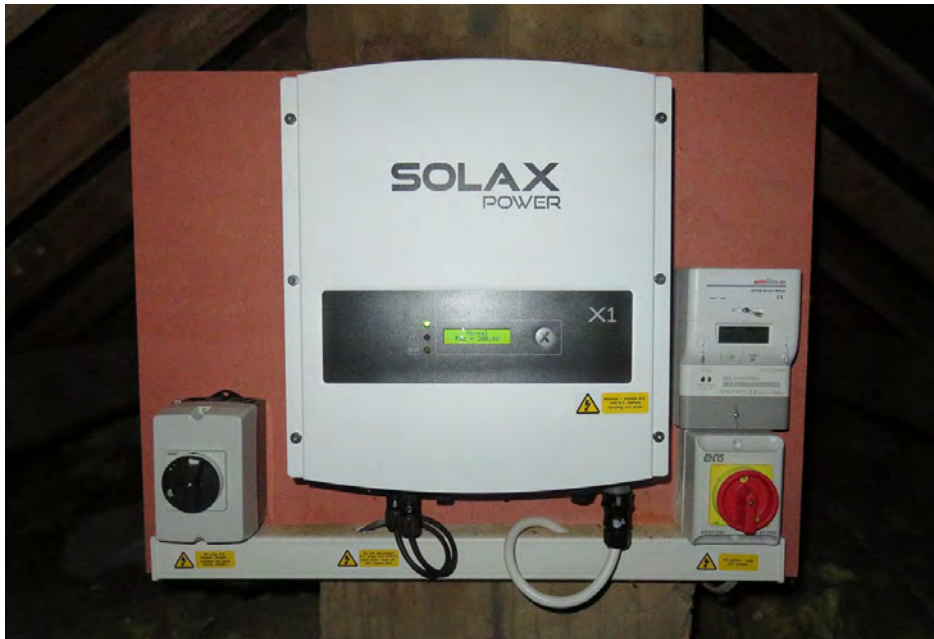
Figure 5.3 shows an example of a SolaX inverter fitted in the loft of a socially rented home. On the left of the inverter is the DC isolator and on the right is the AC isolator with the smart generation meter above it. Much of the cabling has been fitted in plastic trunking.

Figure 5.3 SolaX inverter with the DC isolator, AC isolator and smart generation meter

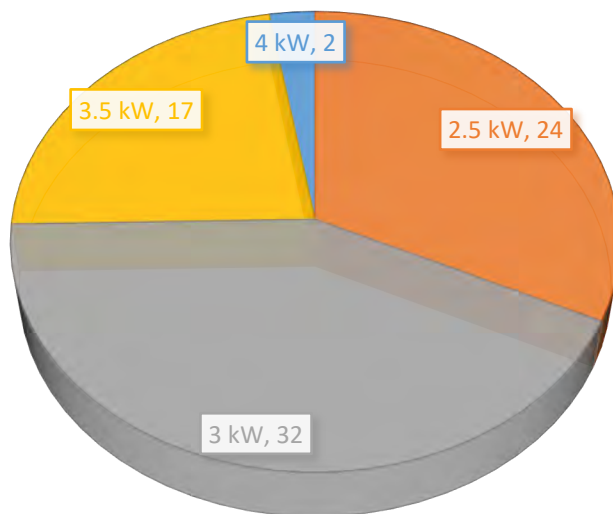
Figure 8.1 Chart showing the sizes of the 75 CCS solar PV systems studied

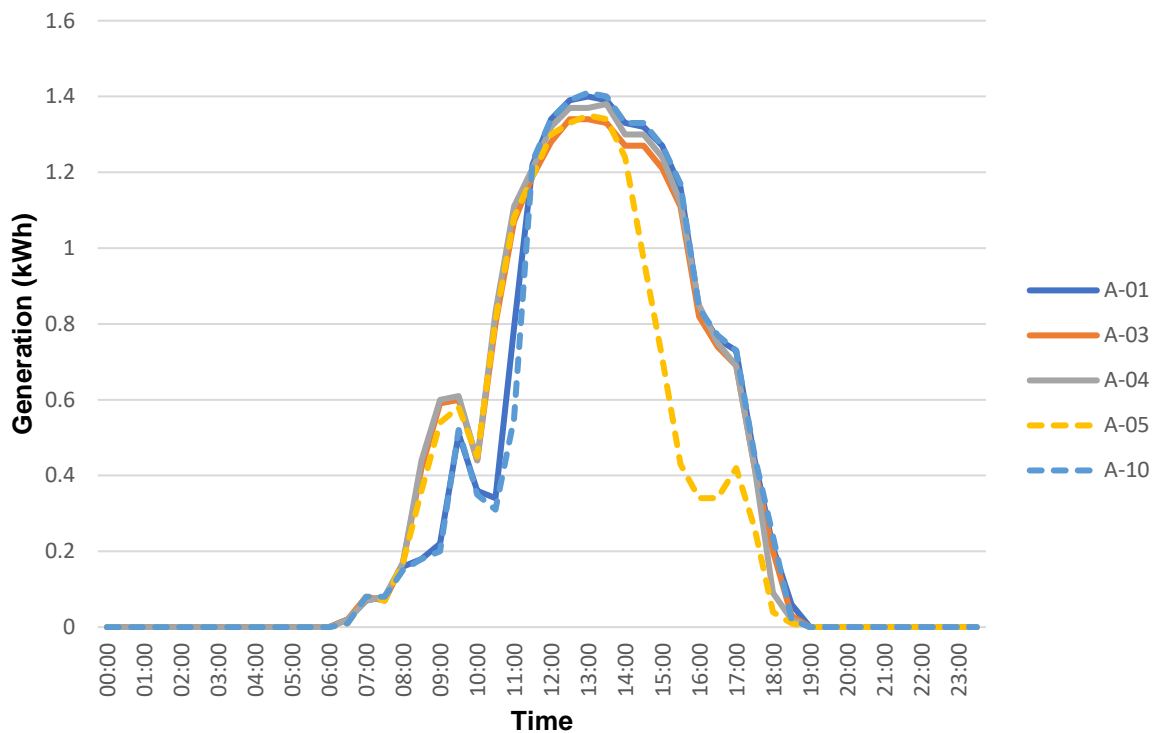
Figure 8.6 shows a graph of half-hourly PV generation against time for 5 of the installations on 29 Mar 21. Although there was a strong generation peak in the middle of the day, the sun was still relatively low in the sky and so there were greater shading issues. In the morning there was reduced generation from installations A-01 and A-10, while in the afternoon, generation from installation A-05 decreased earlier than for the other systems.

Figure 8.6 Graph of Solar PV generation on 29 Mar 21 for households in CCS Area A
